Capitol Region Watershed District

BMP Performance and Cost- Benefit Analysis: Arlington Pascal Project 2007-2010

March 9, 2012

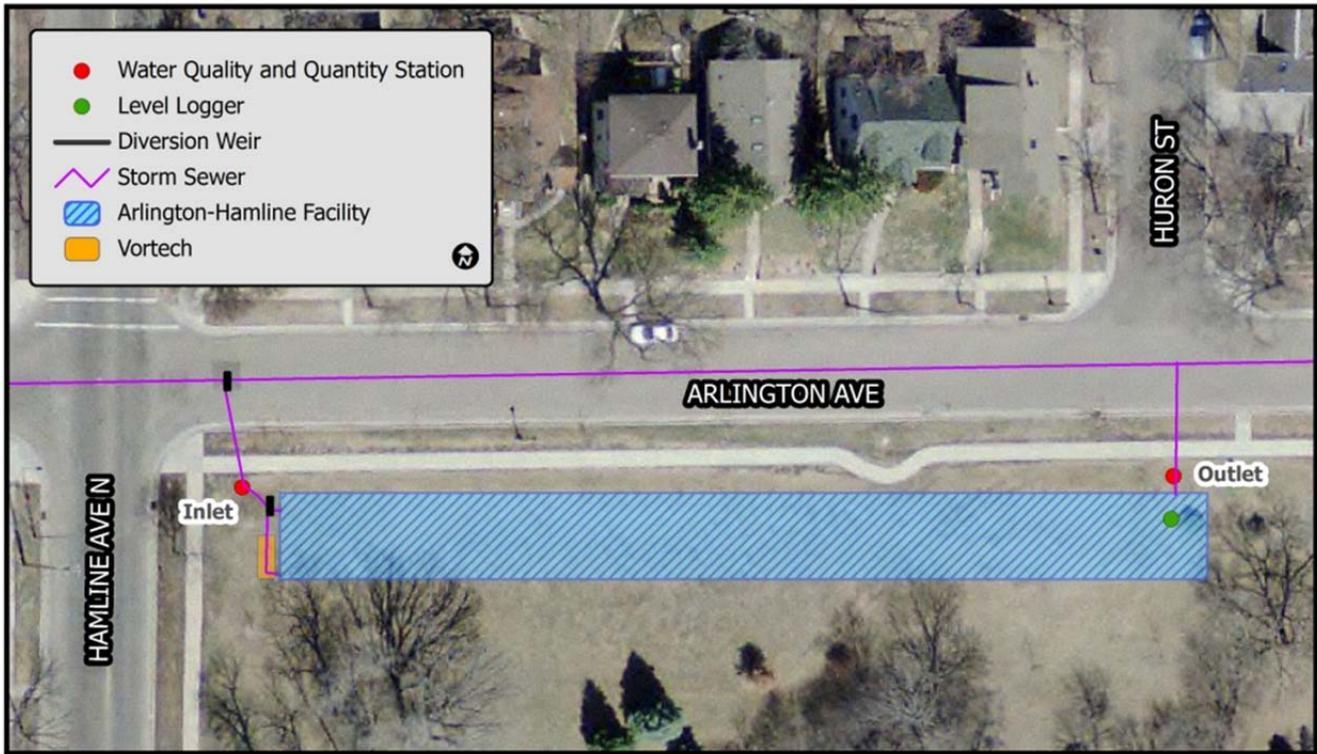
Future monitoring of the Arlington-Hamline Facility will be expanded to include continuous flow monitoring of stormwater runoff which bypasses the facility; the flow which over tops the diversion weir in Arlington Avenue.

Figure 4-2. Arlington-Hamline Facility monitoring locations.

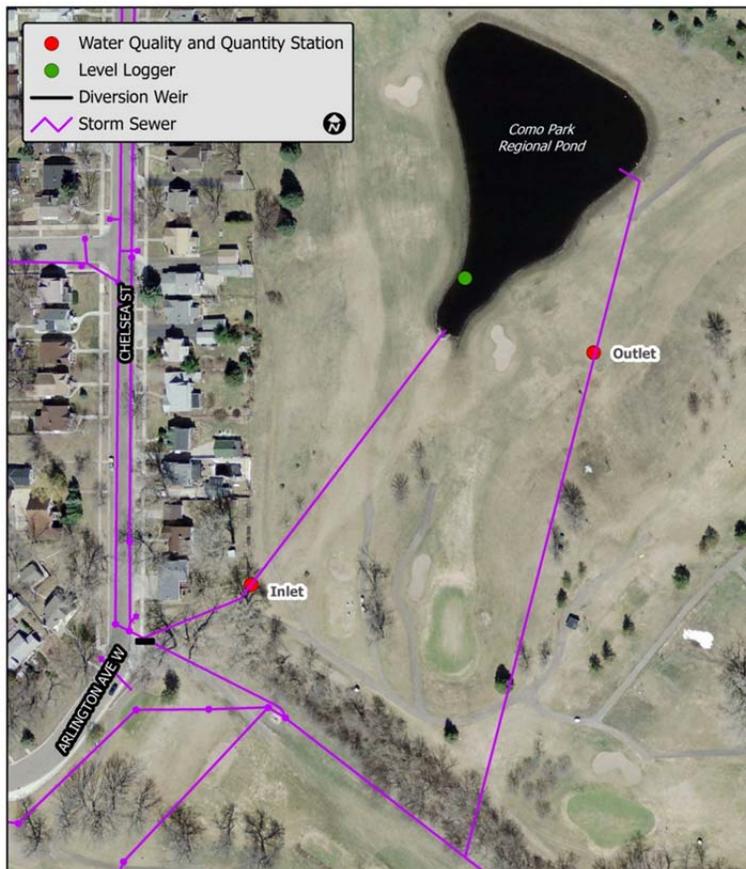
Future monitoring of discharge from the Como Park Pond Outlet will include the collection of instantaneous velocity measurements during periods of dry weather (base flow) throughout the monitoring season. Those measurements will be compared to and/or possibly incorporated in continuous flow data collected at the monitoring site, if accurate data is not collected by the sensor and flow module.

Figure 4-3. Como Park Regional Pond monitoring locations.

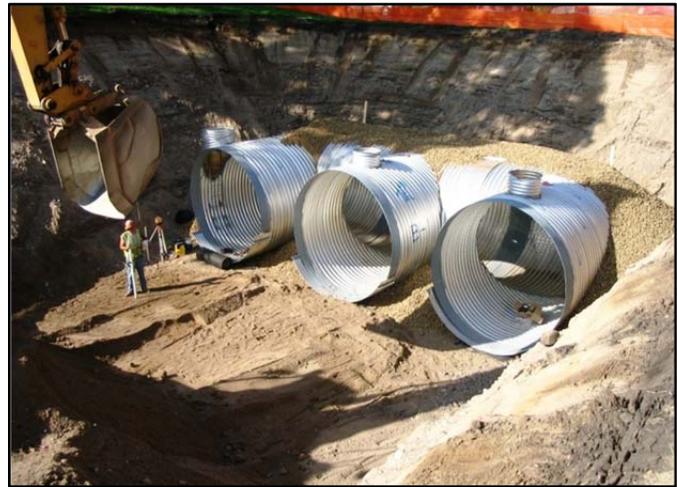
Figure 7-1. Construction of the Arlington-Hamline Facility.

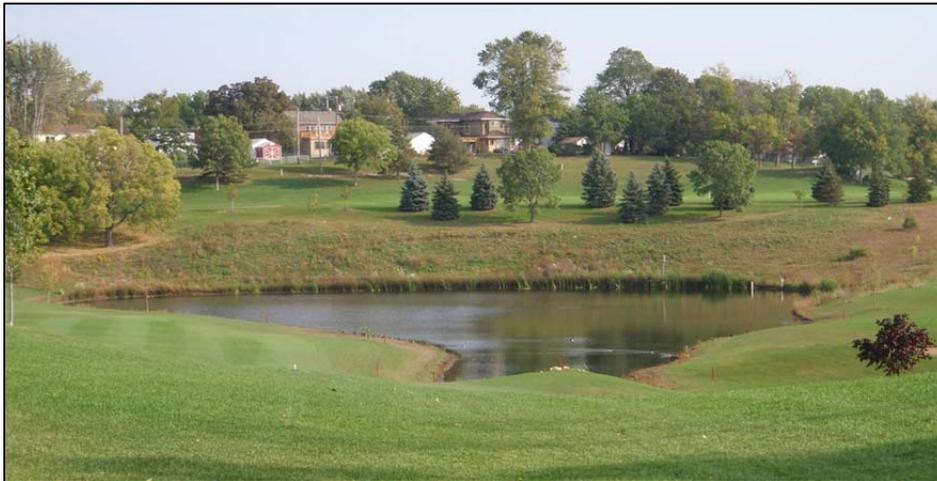
Figure 8-1. Normal water level of the Como Park Regional Pond in September 2009.

The Como Park Regional Pond is a regional stormwater pond that was constructed on the Como Golf Course in St. Paul, between the 3rd and 11th fairways, in 2007 (Figure 2-3, Figures 8-1 and 8-2). Construction of the pond involved re-grading an existing depression to allow for the storage and treatment of runoff via a multi-stage gravity outlet.

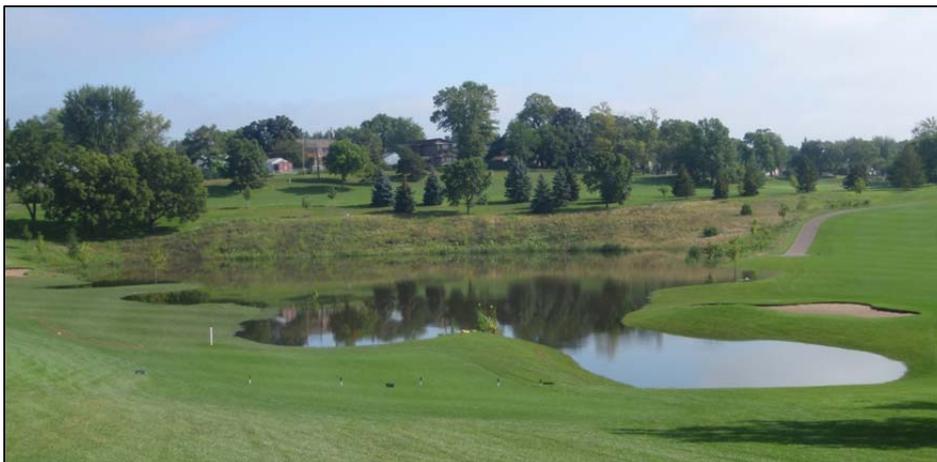
Figure 8-2. The Como Park Regional Pond after a rainfall in August 2010.

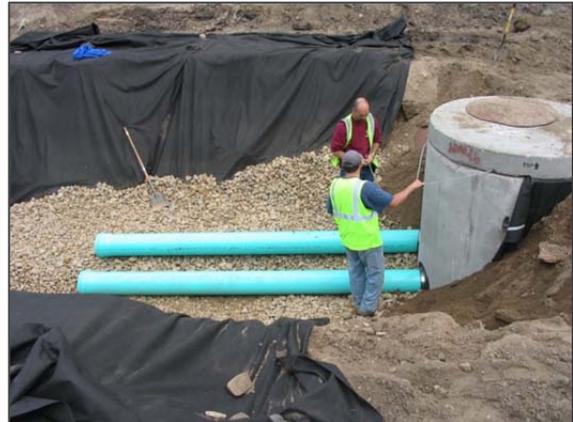
Figure 9-1. Construction of an infiltration trench.

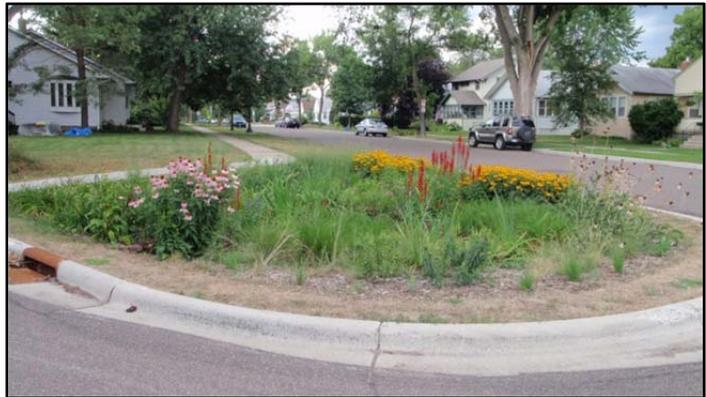
Figure 10-1. Pascal South Rain Garden.

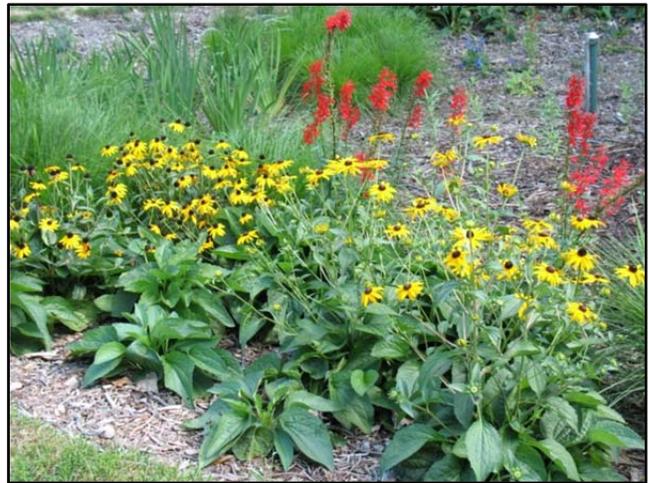
Figure 10-2. Common rain garden plants species.

All rain gardens were planted with a combination of perennial, native forbs and sedges, with the exception of the Hamline Midway Rain Garden which was planted with mostly trees and shrubs (Figure 10-2). Though plant species and abundance varies from garden to garden, the most commonly found plant species in the seven rain gardens are as follows:

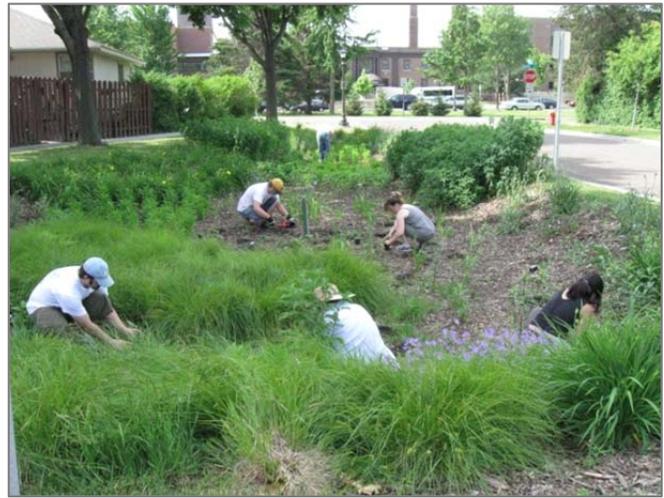
Figure 10-6. CRWD staff and volunteers conducting maintenance in the Asbury South Rain Garden, 2008.

The field crew exclusively provided maintenance assistance to the Hamline Midway Rain Garden. Since 2008, CRWD has also received assistance from neighborhood volunteers for maintenance of rain gardens. CRWD staff, City of St. Paul staff, Conservation Crew of Minnesota staff, and volunteer hours are reflected in annual labor hours and labor costs in Table 10-6. A labor rate of \$0.00 was applied to volunteer hours in the labor cost calculation.

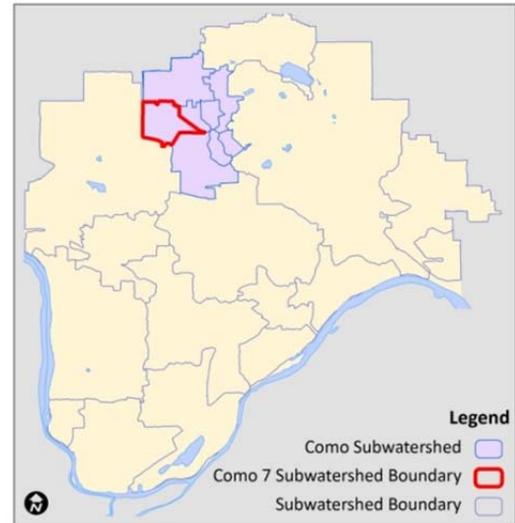
Figure 1: Como 7 Subwatershed project area.

The Capitol Region Watershed District (CRWD) constructed eighteen stormwater best management practices (BMPs) for the Arlington Pascal Stormwater Improvement Project; a multi-jurisdictional project centrally located within the Como 7 Subwatershed in St. Paul, Minnesota (Figure 1). The project ultimately aimed to achieve pollutant load reductions (particularly total phosphorous (TP)) to Como Lake while addressing intercommunity flooding issues and storm sewer improvements.

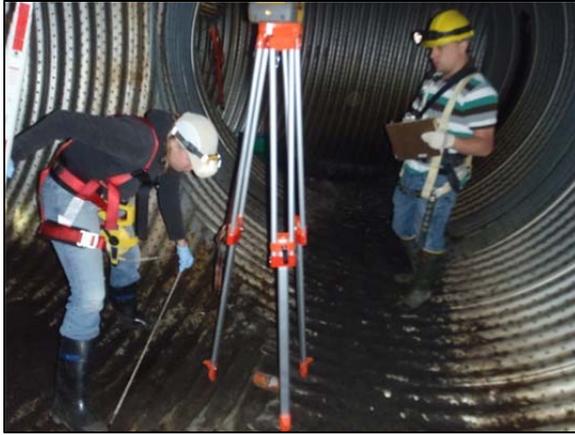
Figure 10: Longitudinal survey of pipe 2. Length measurement of the gross solids deposit (LEFT). Measurement of gross solids deposit elevation and depth (RIGHT).

Fifteen samples were collected from within the pipe gallery at equidistant sampling locations, in each pipe (Pipe 1, 2, and 3). Sampling points were established every 55-feet in each pipe (Pipe 1, 2, and 3), resulting in five sampling points per pipe (Sampling Point 1, 2, 3, 4, and 5). At each sample point, the gross solids coring device (Figure 8) was used to extract individual samples across the entire cross-section of the gross solids deposit; length and if necessary, width wise (Figure 9). Figures 10, 11, and 12 portray data and sample collection efforts.

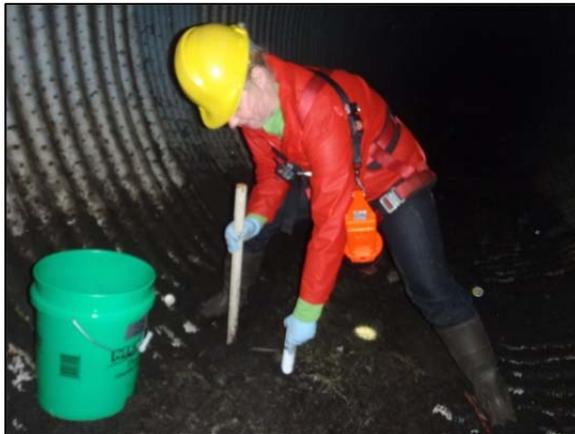
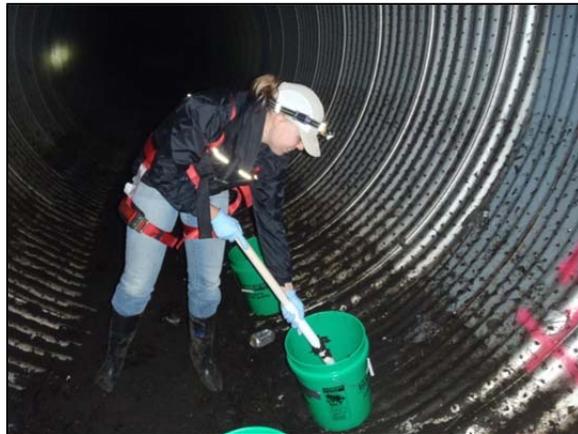
Figure 11: Gross solids sample collection. Extracting sample from the deposit (LEFT). Removal Of the sample from the coring device, into a bucket (RIGHT).

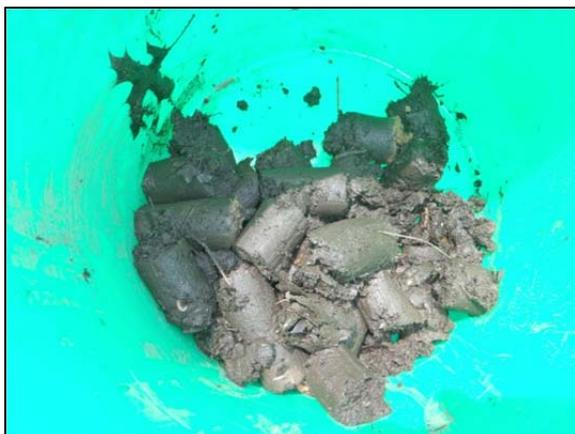
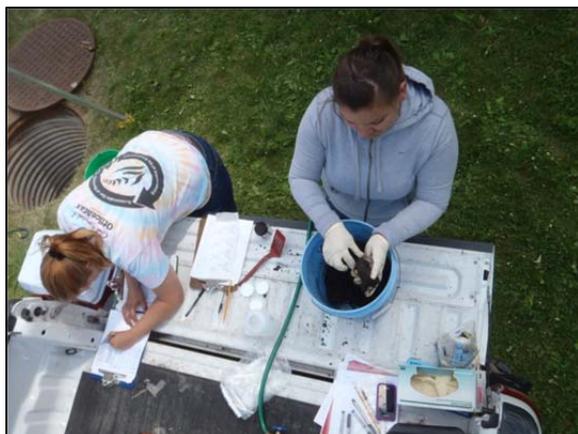
Figure 12: Gross solids sample, before compositing, taken from a sampling point within the pipe gallery (LEFT). Sample preparation (RIGHT).

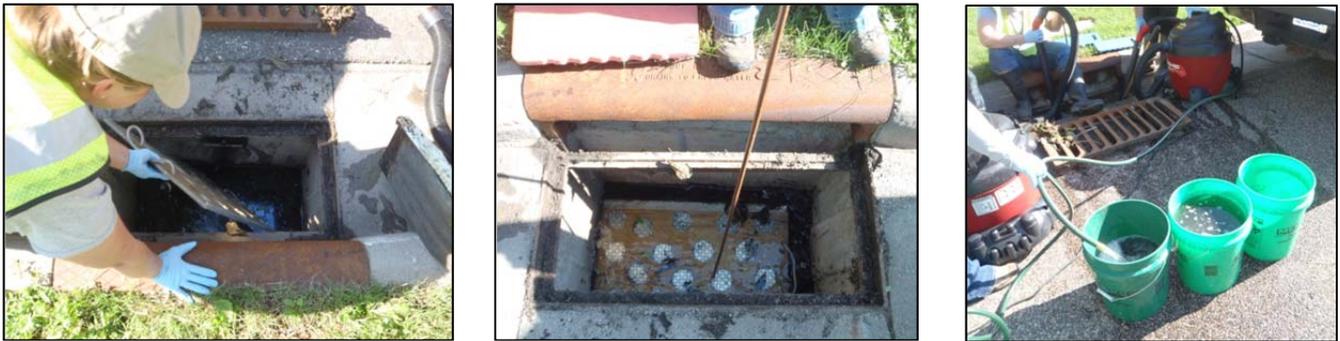
Figure 14: Placement of the sump screen in to the catch basin (LEFT). Submerging the sump screen (CENTER). Decanting water from a catch basin (RIGHT).

Before a sample could be collected from a catch basin, the stormwater was first decanted using two wet/dry vacuums. A sump screen was placed into the catch basin and held underwater on top of the gross solids deposit (Figure 13). This screen allowed for the water in the catch basin to be decanted without disturbing or re-suspending the material in the catch basin. Each vacuum was equipped with a pump which allowed for the water to be pumped from the catch basin and into buckets which were emptied into a sumped manhole that drained to an infiltration trench. This enabled the vacuums to run continuously until all water was decanted from the catch basin

Figures 14 through 16 illustrate sample collection efforts for a sumped catch basin.

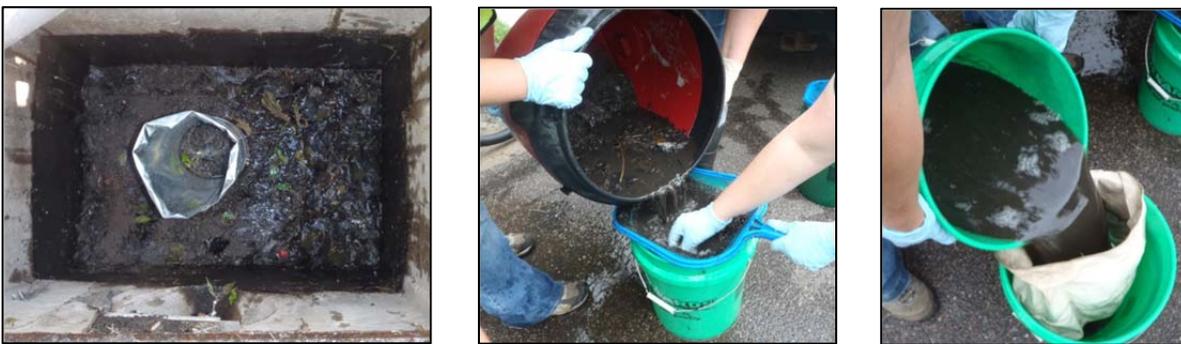
Figure 15: Placement of the stove pipe in a catch basin (LEFT). Sample material collected from a catch basin being strained through the first screen (CENTER) and through the second screen (RIGHT).

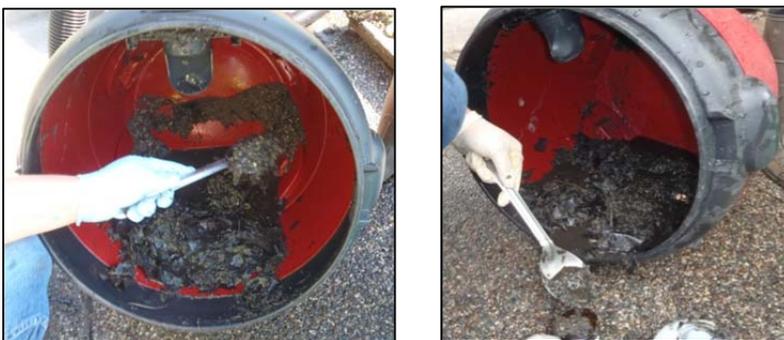
Figure 16: Mixing of the sample material (LEFT). Placement of the samples material in to the sample container (RIGHT).

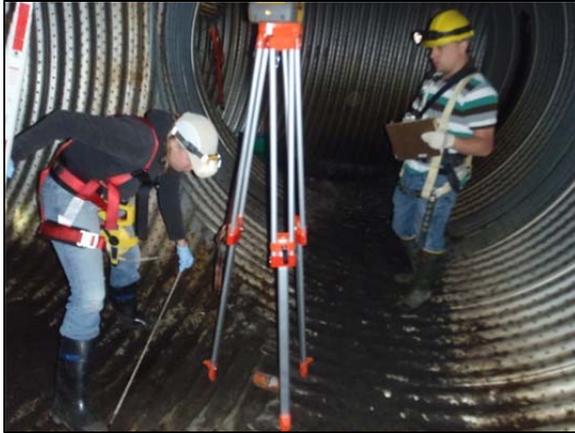
Figure A-4: Longitudinal survey of pipe 2. Length measurement of the gross solids deposit (LEFT). Measurement of gross solids deposit elevation and depth (RIGHT).

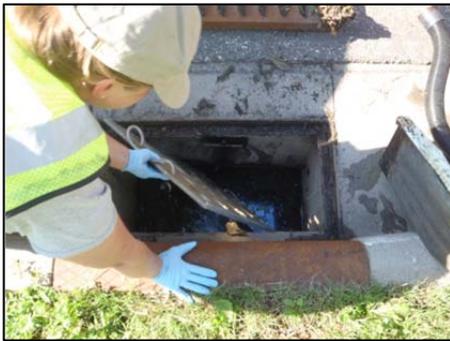
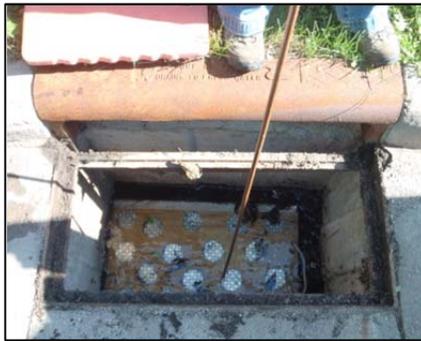
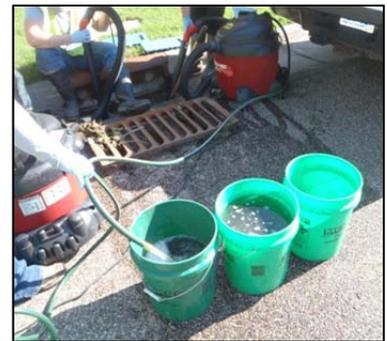
Figure A-8: Placement of the sump screen in to the catch basin (LEFT). Submerging the sump screen (CENTER). Decanting water from a catch basin (RIGHT).

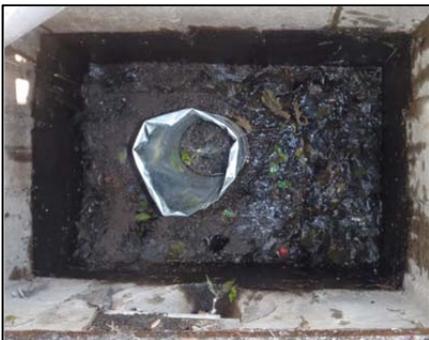
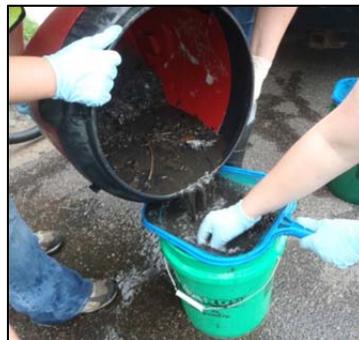
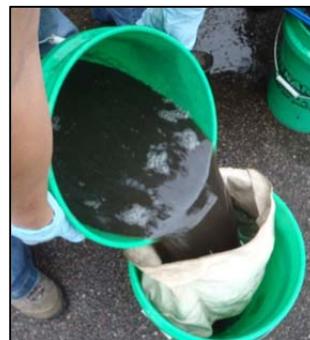
Figure A-9: Placement of the stove pipe in a catch basin (LEFT). Sample material collected from a catch basin being strained through the first screen (CENTER) and through the second screen (RIGHT).

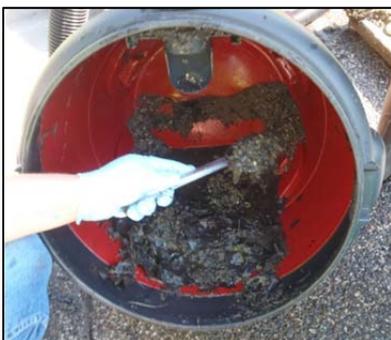
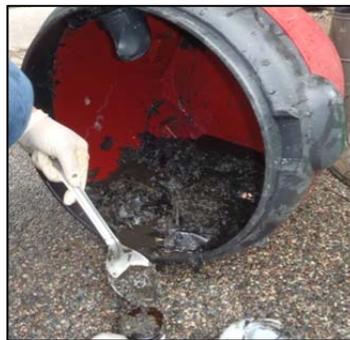
Figure A-10: Mixing of the sample material (LEFT). Placement of the samples material in to the sample container (RIGHT).
