Crosby Lake Management Plan

Capitol Region Watershed District
Saint Paul, MN

Prepared by Wenck Associates, Inc.

October 2012

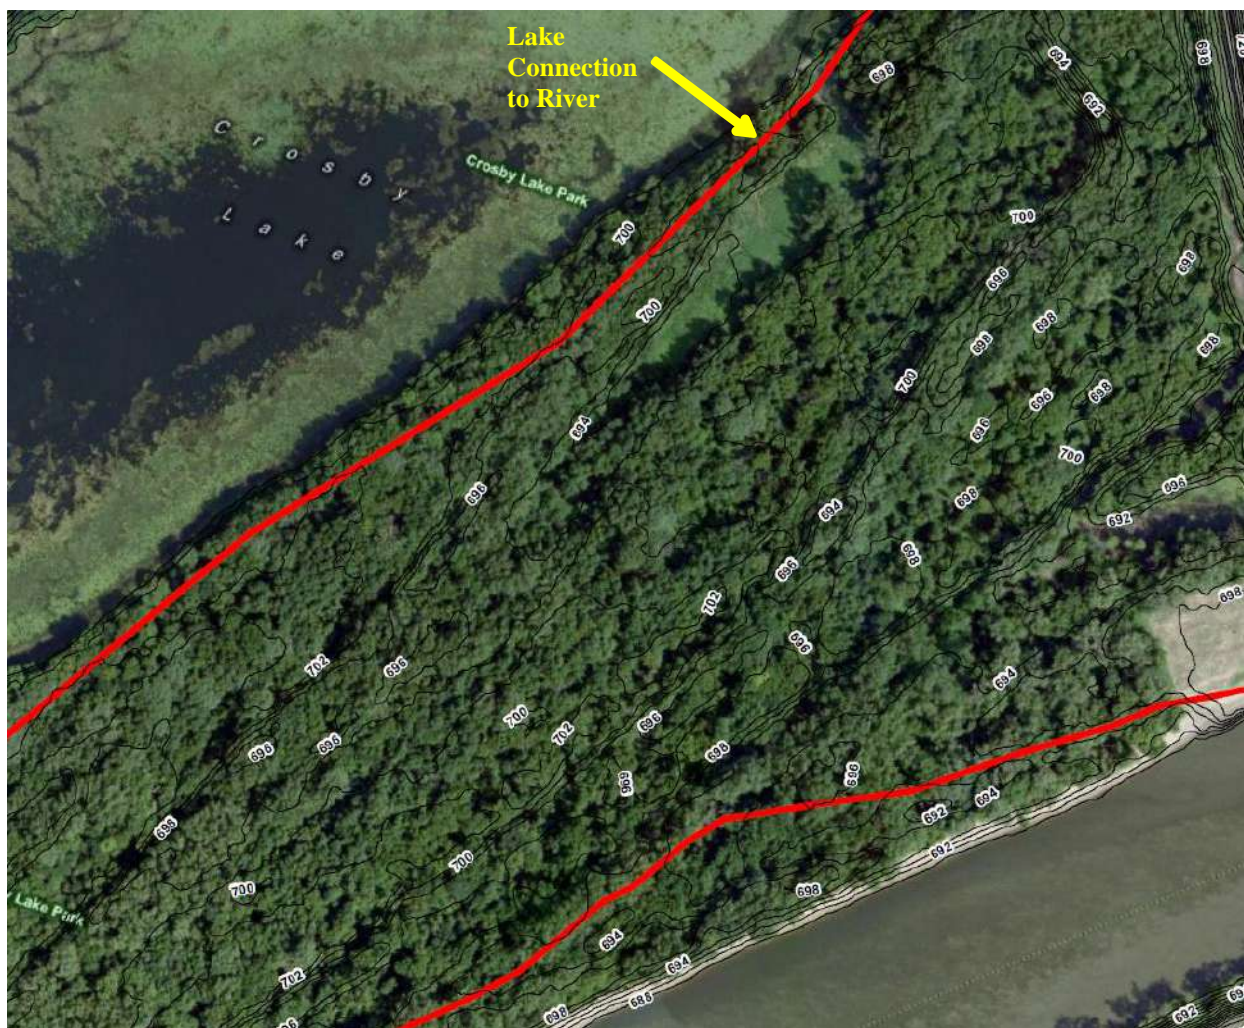
Figure 2-7. Crosby Lake Connection to the Mississippi River

A review of Mississippi River flow and stage data was conducted to develop an understanding of the magnitude and frequency of flood water interaction with Crosby Lake (Appendix B). Using 2-foot contours provided by the City of St. Paul, it appears that the river and lake are “connected” at approximately elevation 697. The connection occurs at the southeast corner of the lake where there is a break in the 698 contour (Figure 2-7). There appears to be a flow path from this point and southeast to the river.

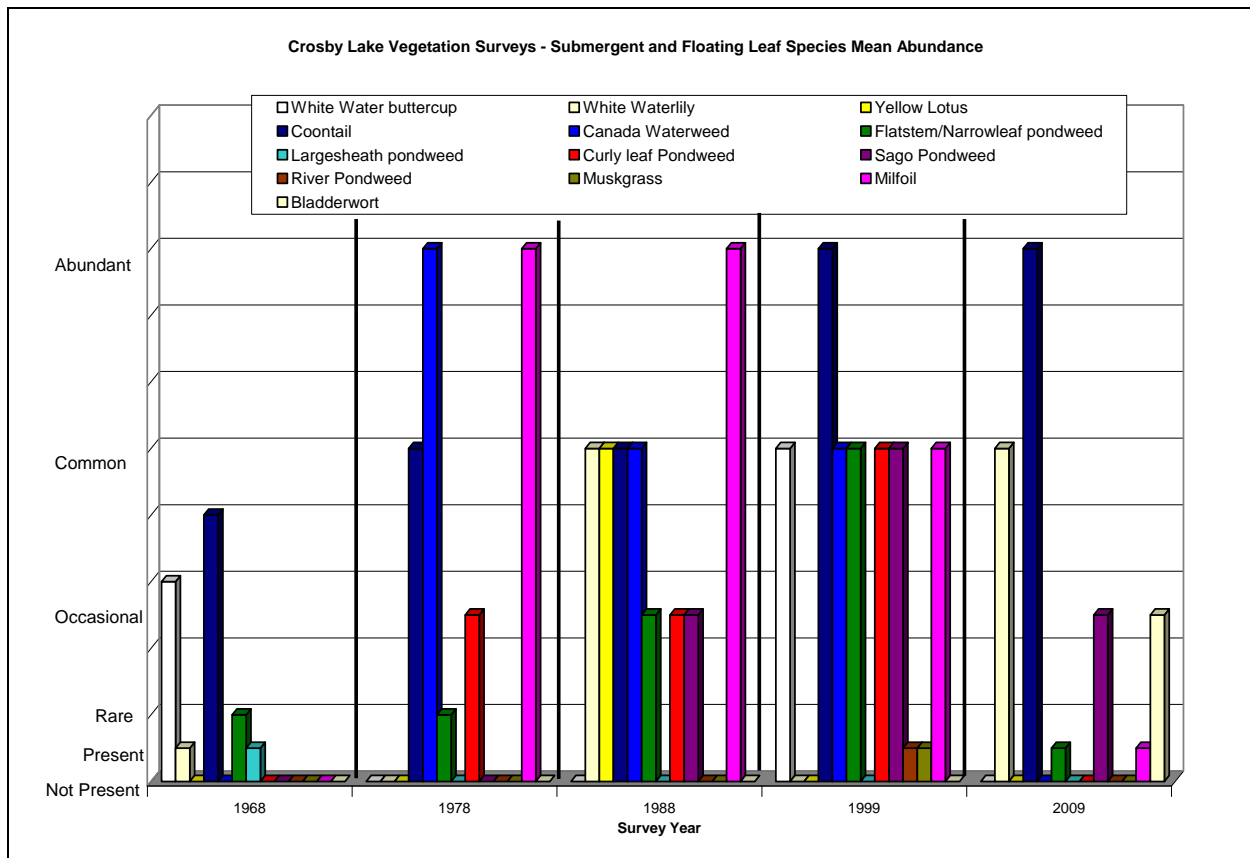
Figure 2-13. Submerged Aquatic Vegetation in Crosby Lake

Vegetation data was compiled from MN DNR fish surveys and Ramsey County to develop a general history of vegetative conditions in Crosby Lake (Figure 2-13). MN DNR surveys were conducted as far back as 1968 and then in 1978, 1988, and 1999. The most recent survey was conducted by Ramsey County in 2009. In general, submerged aquatic vegetation has been dominated by coontail since 1968. Coontail is typically found in more eutrophic shallow lakes and can develop nuisance abundances that choke out other native species. However, Coontail does not appear to have reached these conditions in Crosby Lake. Other species such as muskgrass, native milfoil, and Canada waterweed are also common in Crosby Lake. The 2009 survey, however did find a greater dominance by coontail suggesting that the lake is becoming

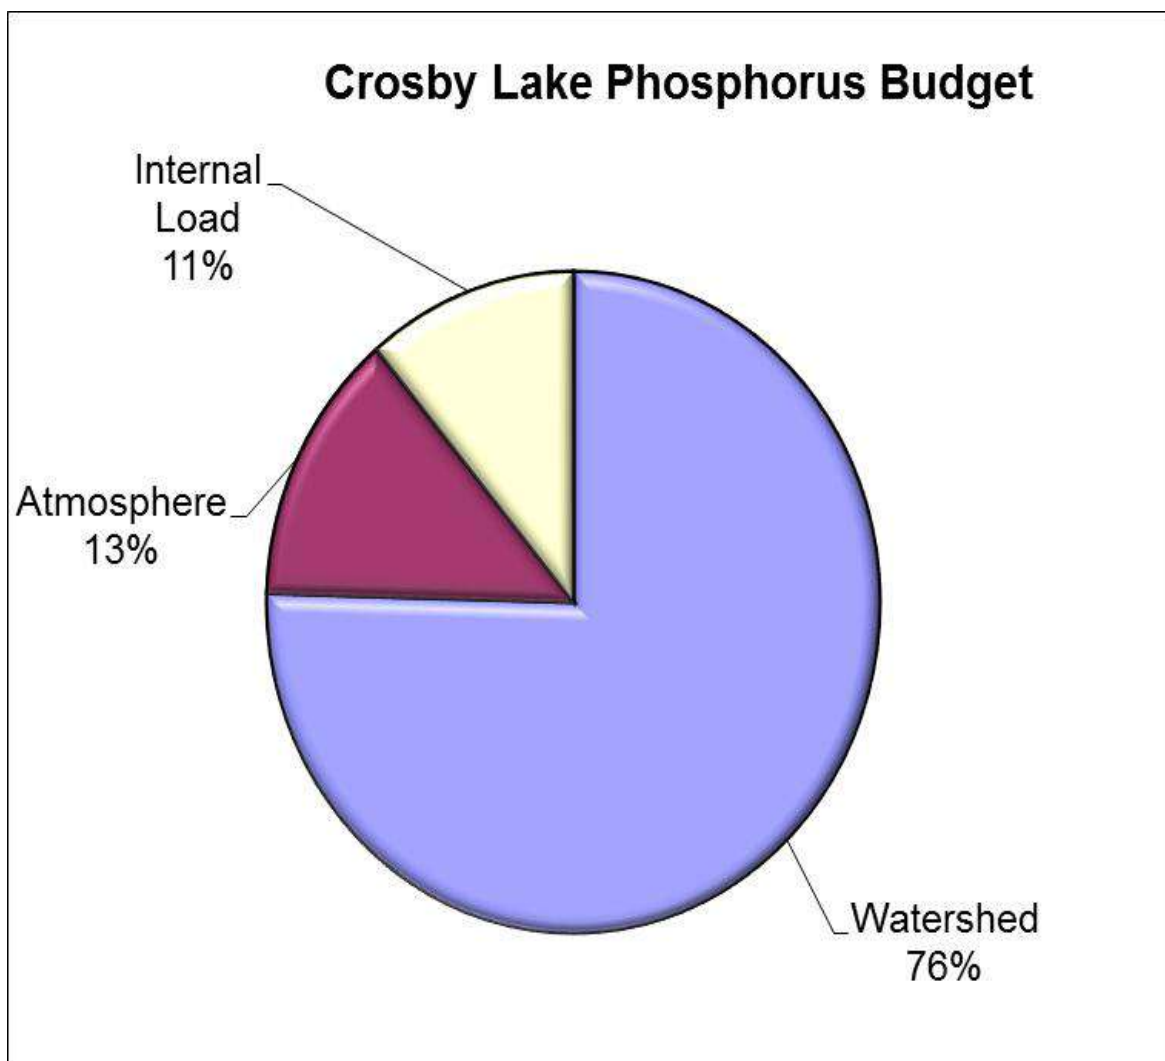
Figure 2-15. Total Phosphorus Budget for Crosby Lake

A BATHTUB model of the average of all monitoring years was used to determine the current total phosphorus budget for Crosby Lake and identify necessary reductions to meet goals identified in Section 3.3. Phosphorus sources are dominated by watershed runoff (drainage areas) accounting for 76% of the phosphorus entering Crosby Lake (Figure 2-15). Internal loading was determined to be a small percentage (11%) of the phosphorus budget although high concentrations of phosphorus were measured in the bottom waters. Because there is such a small deep hole that goes anoxic, this source represents a relatively small proportion of the overall budget. Consequently, watershed sources of phosphorus are the primary driving force for water quality in Crosby Lake. High phosphorus release by sediments should not be ignored however as this can lead to other problems such as filamentous algae blooms.

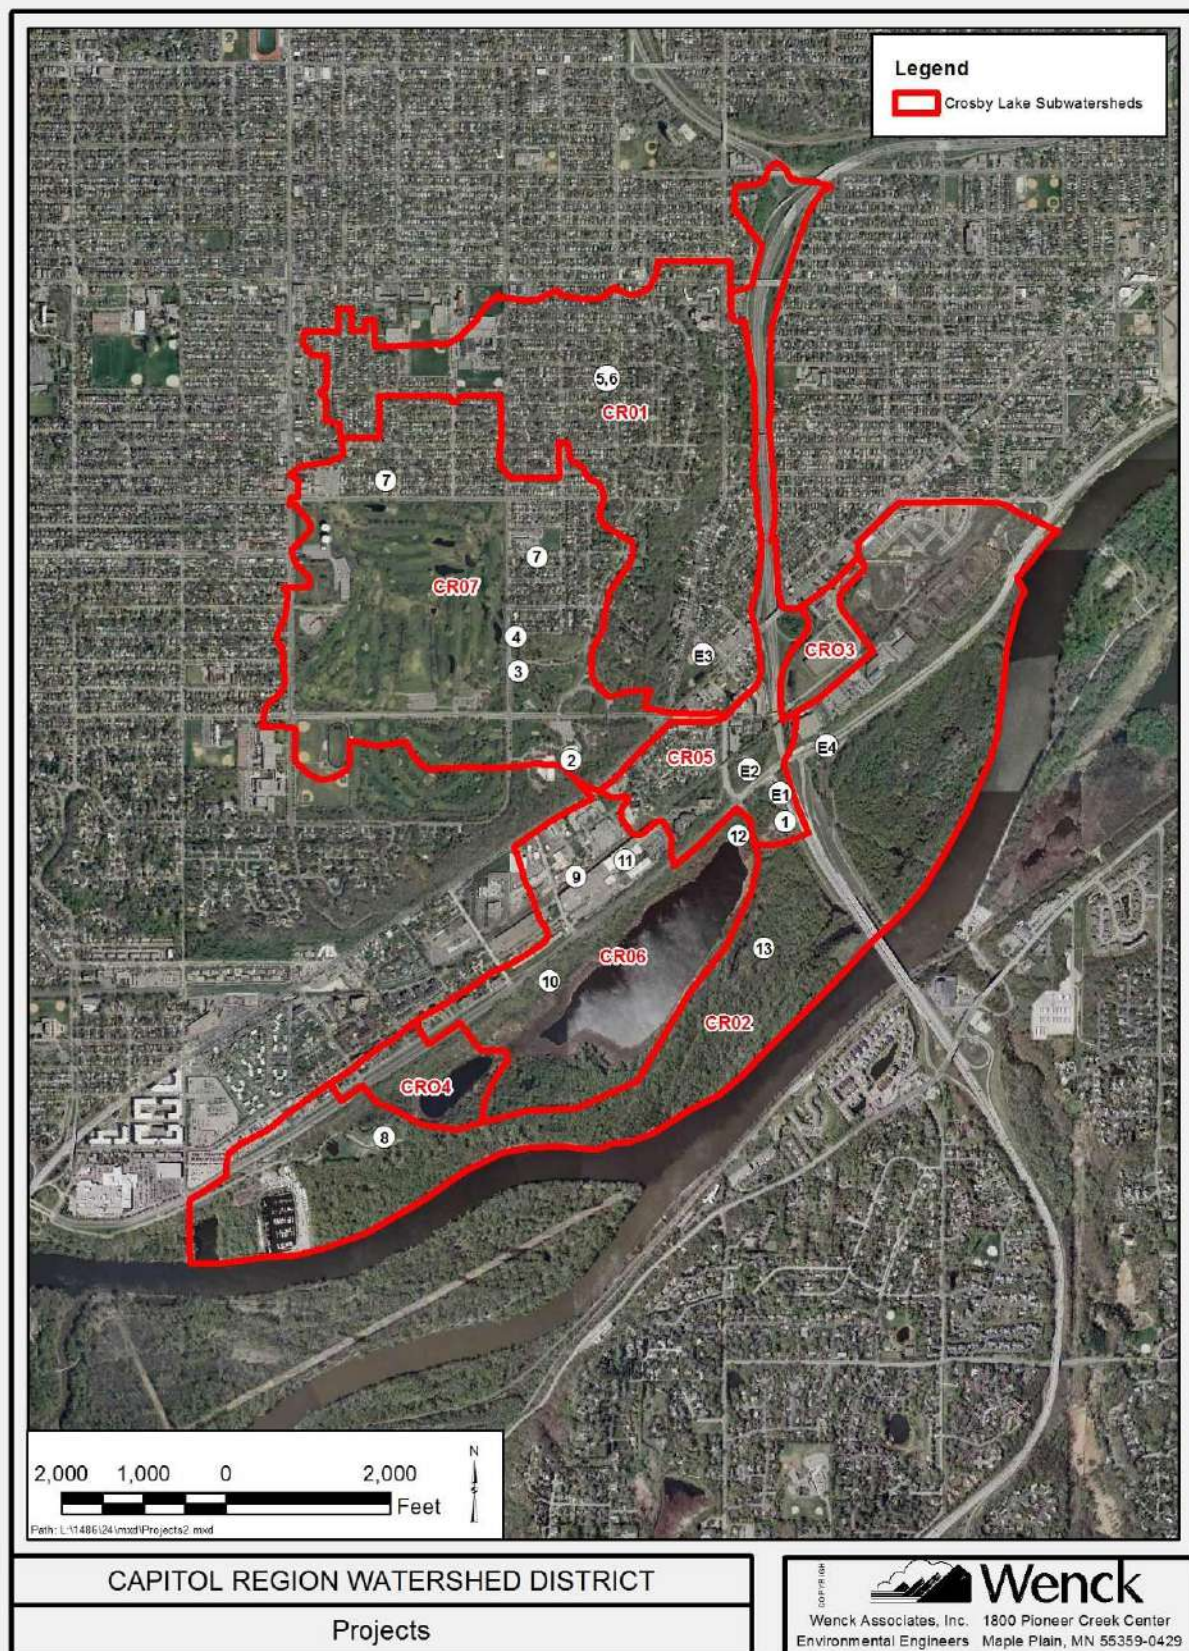
Figure 4-1. Location of Projects to Address Water Quality in Crosby Lake and Runoff to the Mississippi River

The purpose of this plan is to identify water quality goals for management of Crosby Lake and the Crosby Subwatershed and to identify projects necessary to reach those goals. To that end, CRWD, the Technical Advisory Group, and the Citizens Advisory Group (CAG) identified a list of projects to address water quality in the watershed and Crosby Lake. Almost 30 potential projects were identified; however, some were eliminated due to poor site conditions. The remaining projects have been evaluated and included in this plan (Figure 4-1). Following is a discussion of the potential projects for the watershed.

Several projects were evaluated and determined to be infeasible based on physical conditions at the site. Following is a brief description of the evaluated options. See Figure 4-1 for project locations.

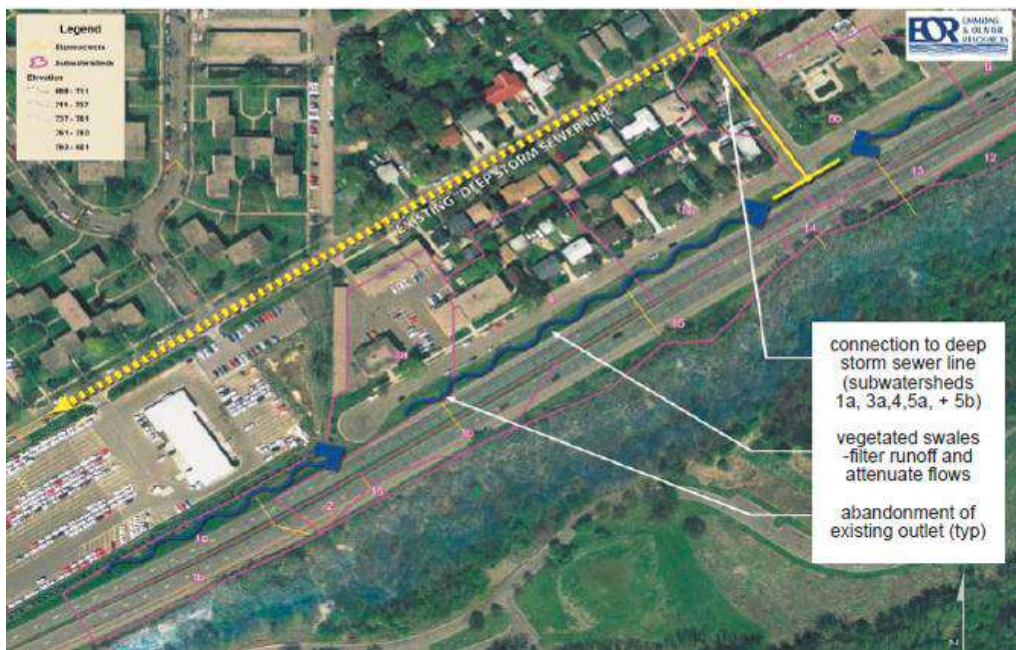
Figure 4-4. Subwatershed CR02 Stormwater Diversion

The areas diverted by the stormwater diversion are shown below in Figures 4-4, 4-5, and 4-6 from the Crosby Farm Park Bluff Stabilization/Restoration Feasibility Report, followed by the specific areas diverted from subwatersheds CR02, CR04 and CR06.

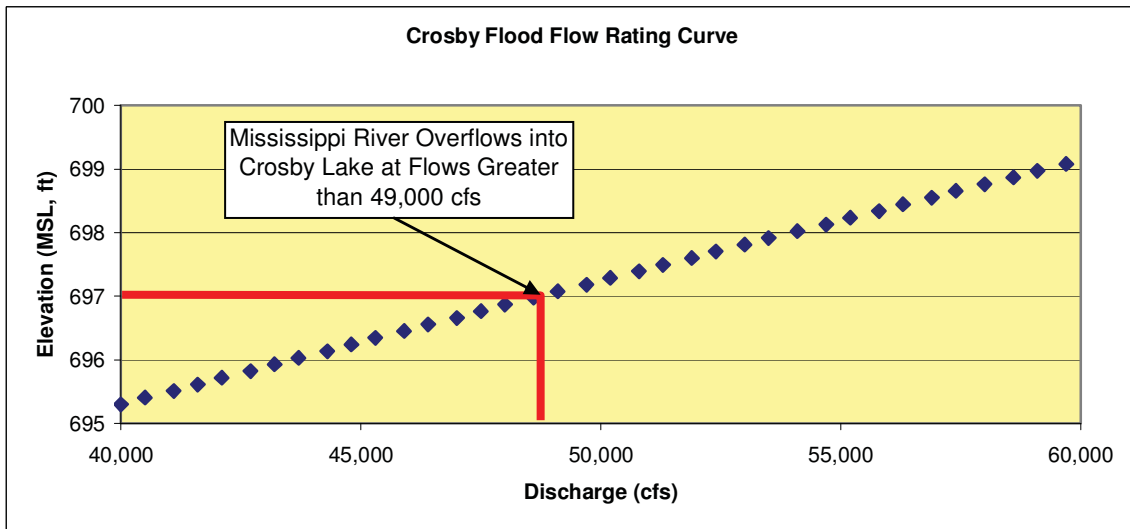
Figure 4. Portion of Mississippi Rating curve at River Mile 843.4 (Crosby Lake).

Based on an overflow elevation of 697, I used a portion of Figure 3 to determine what flow event would cause the river to inundate Crosby Lake (Figure 4).

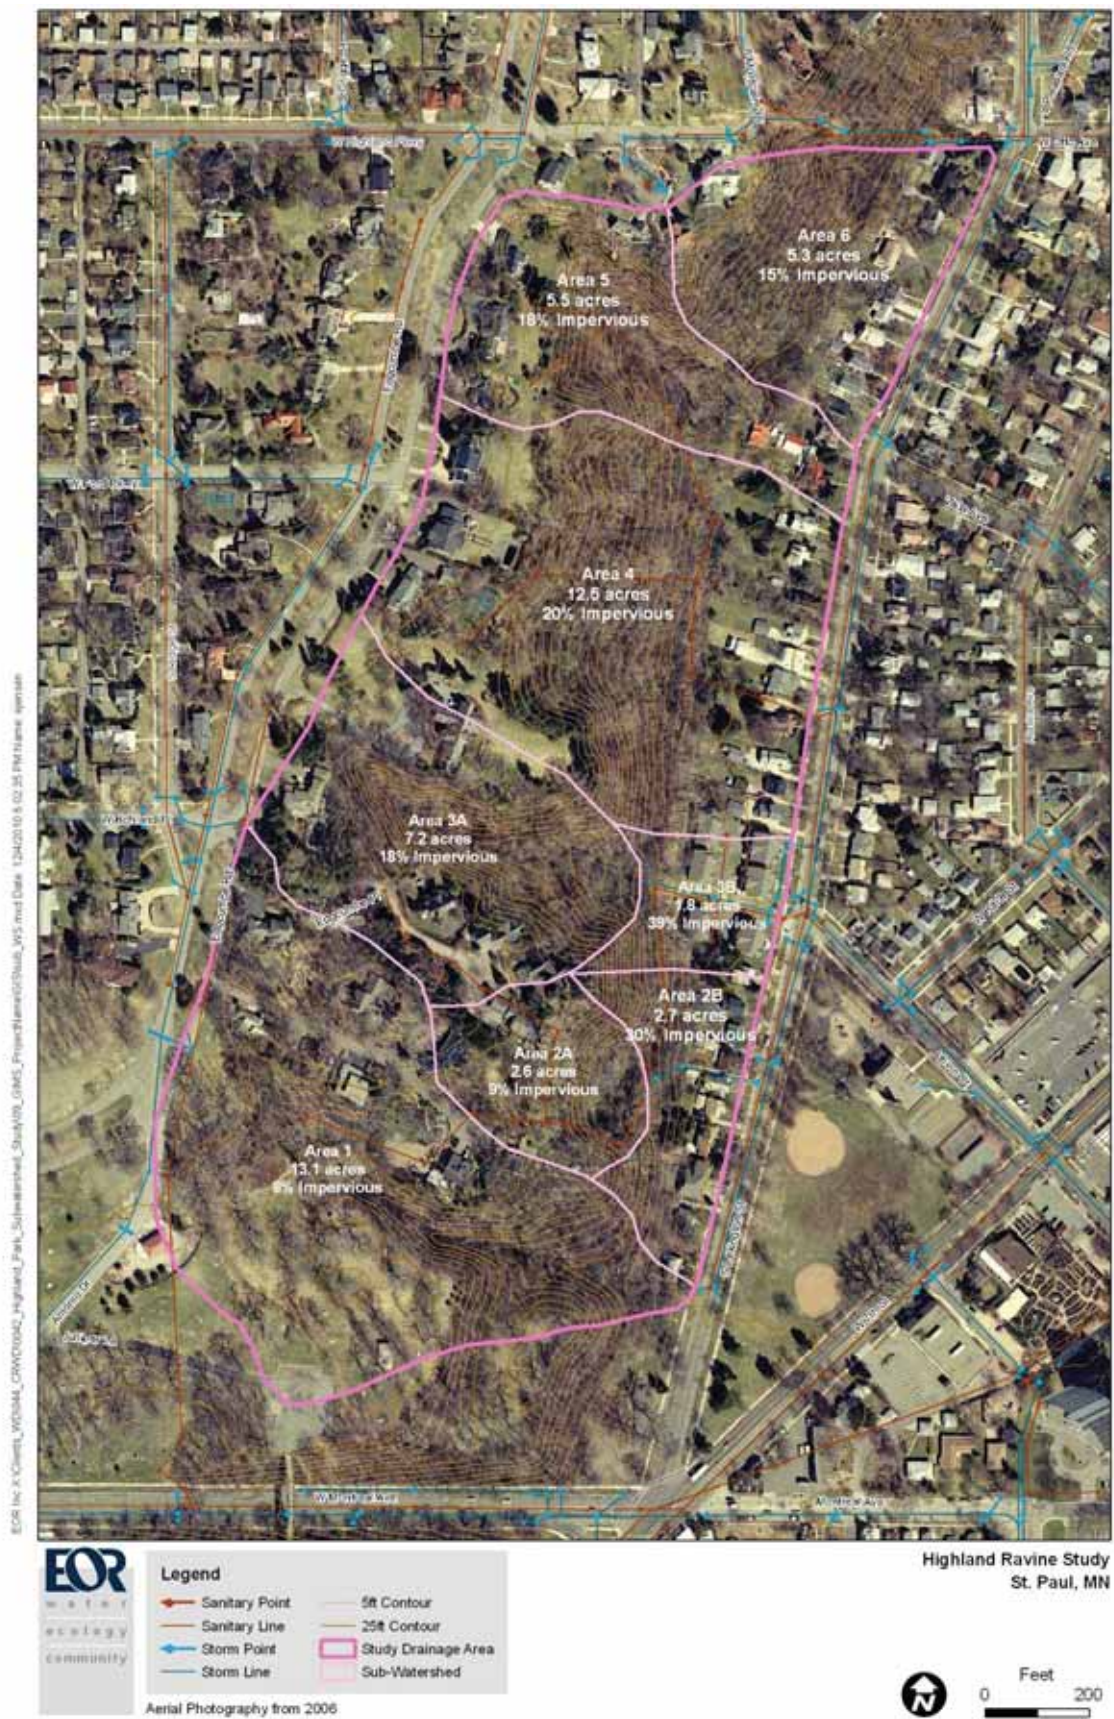
Figure-2 Highland Ravine Catchments

Utilizing existing infrastructure and topographic data, the project area was delineated into separate catchments (depicted in Figure 2). This delineation was verified and corrected via onsite reconnaissance. The project area was divided into six primary drainage or catchment areas as shown in Figure-2. Of these six catchment areas, four of the catchments, (2, 4, 5, and 6) were determined by EOR and CRWD staff to not have significant issues of concern either observed during the site visit or expressed by local residents. To provide a more detailed assessment of the areas of concern, Catchments #1 and #3 were further evaluated during a detailed survey completed by EOR staff on December 3, 2010.

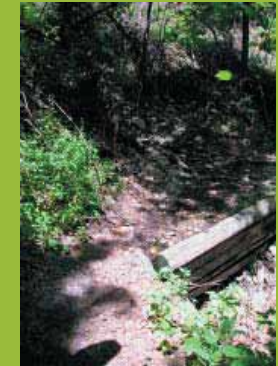
Water on trail, gabion's recommended.

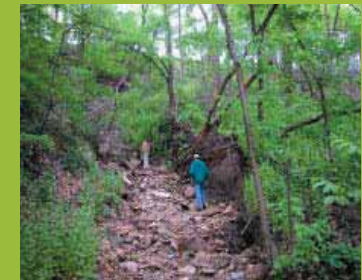
Another severely eroded gorge, above, with the cause of its erosion, a storm water pipe, below.

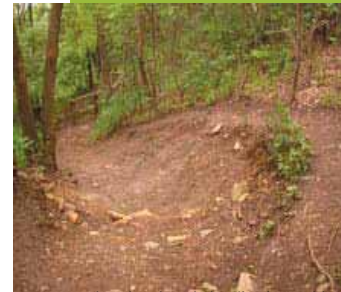
Sloped and eroded trail, where wide stairs are recommended.
